**Interstate 405  
PM 2.9 to PM 9.0**

## **DOWEL BAR RETROFIT EVALUATION**

### **PRELIMINARY REPORT**

**DISTRICT 12  
Orange County  
Interstate 405  
Contract Number: 12-0A1104**

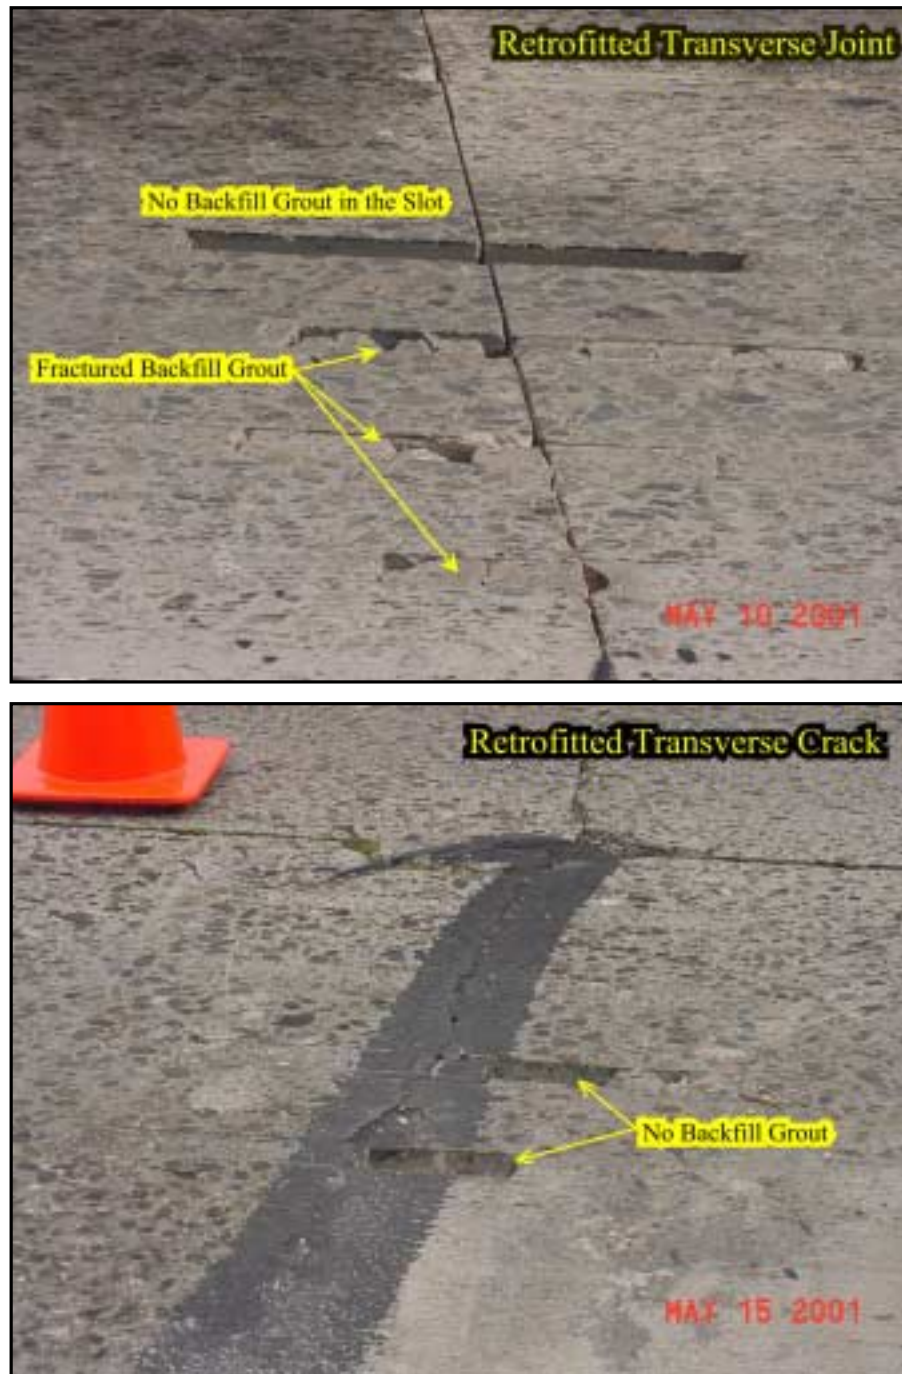
**Figure 5.** Loose Backfill Grout

Pavement inspections were performed on Thursday, May 10, 2001 and May 15, 2001. Several panels along the retrofitted segment were examined. The backfill grout at some dowel bar installations was fractured and loose in the slot. At other locations, the backfill was missing completely, exposing the dowel bar.

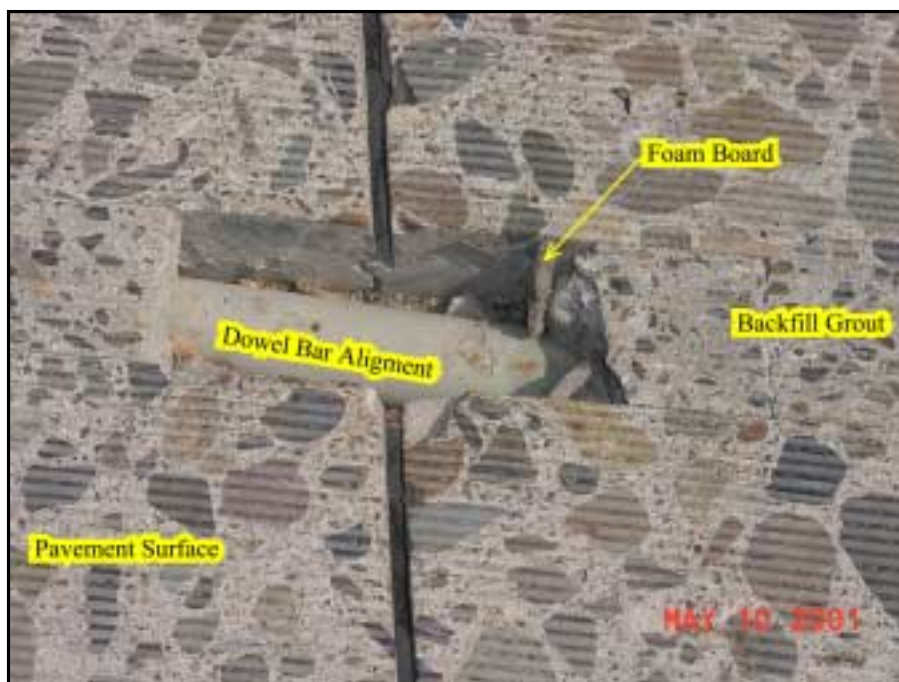
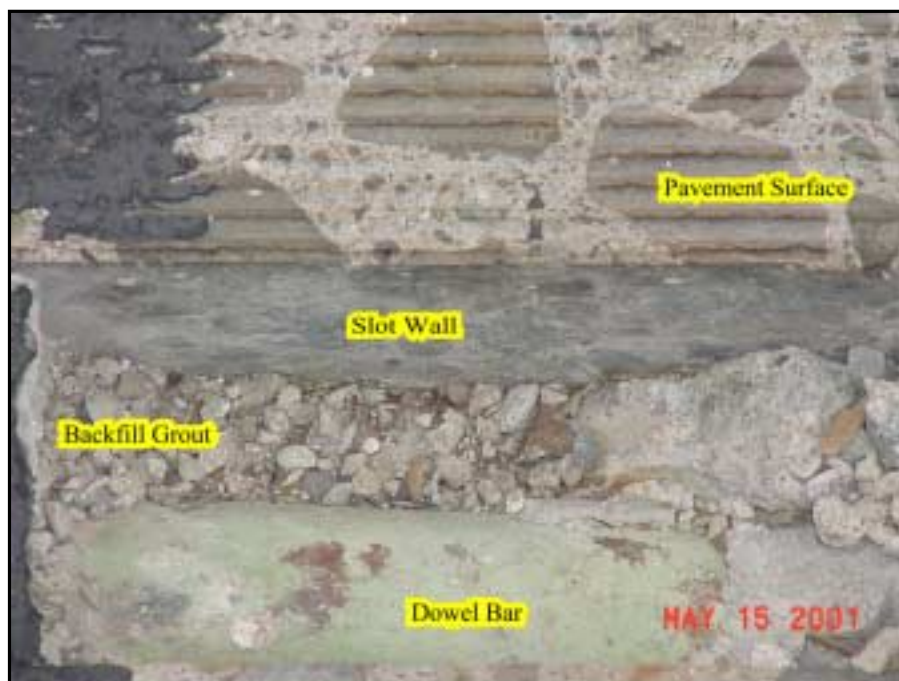
**Figure 6.** Exposed Dowel Bars

At locations where the grout was missing, it could be seen that the bond between the grout and pavement had failed. The exposed dowel bars appear to be too close to the pavement surface and vertically misaligned.

The inspected dowel bars did not conform to the positioning requirements specified in the project plans. The center of the dowel bars should be 100 mm below the surface of the 200 mm thick pavement.

In order to affectively provide load transfer, the dowel bars should be placed in accordance with the project plans and specifications.

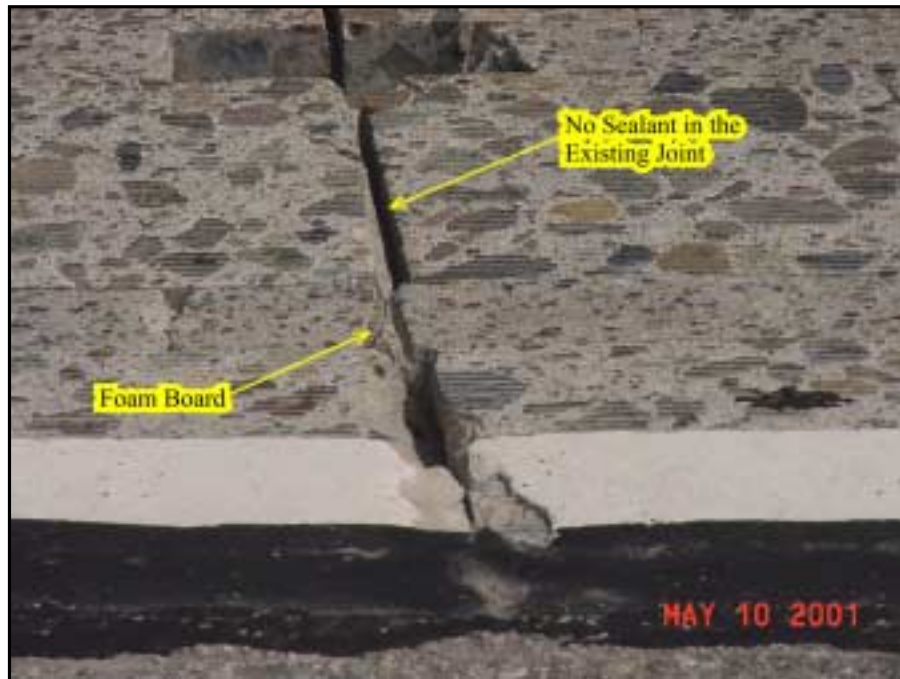
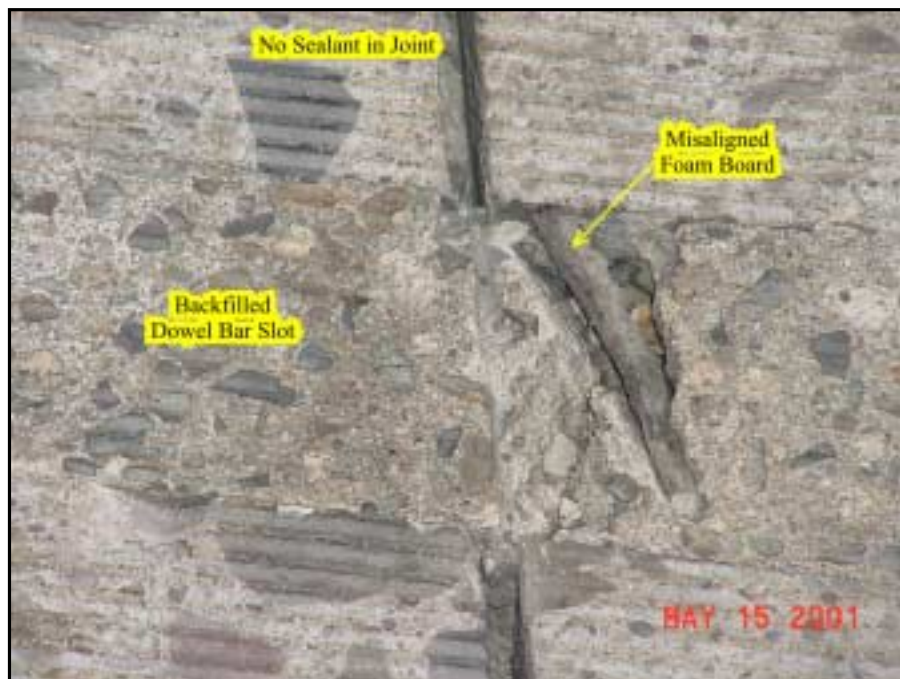
**Figure 7.** Foam Board Alignment

Foam boards were not aligned with the existing transverse joint. The joints were not filled with backer rod and joint sealant.

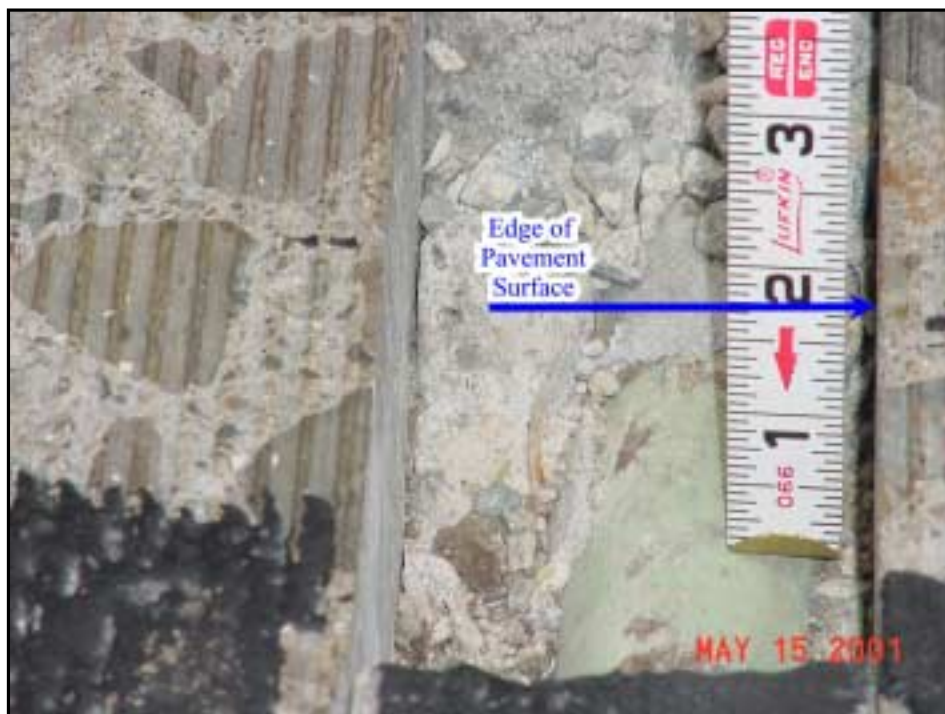
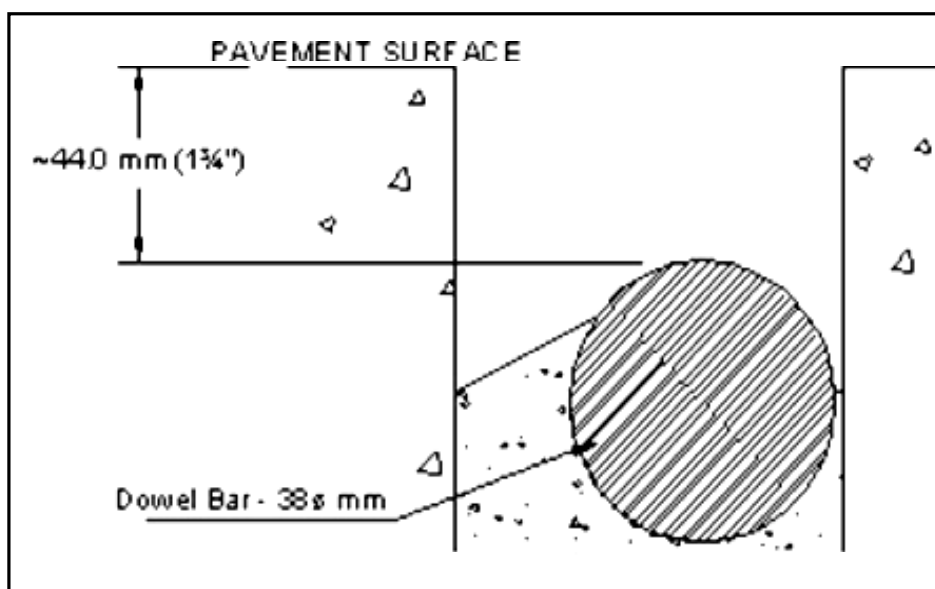
**Figure 8.** Dowel Bar Placement

A closer examination of an exposed dowel bar at the transverse crack revealed that the dowel bar was approximately 44-mm (1¾-in.) from the pavement surface and is not centered in the slot.

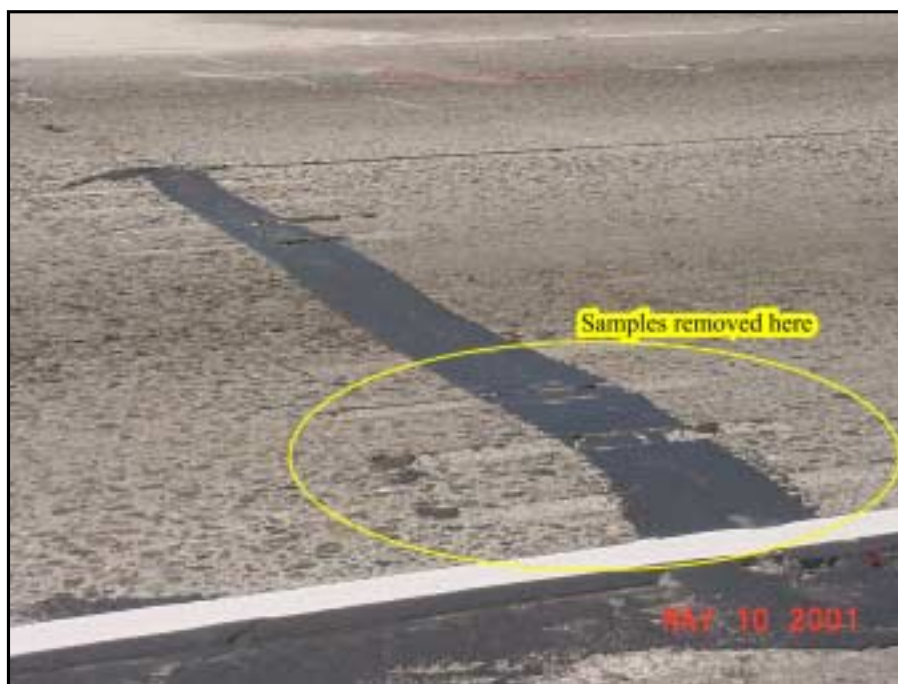
**Figure 9.** Retrofitted Transverse Crack

The dowel bar installations, shown in Figure 9, were removed from a retrofitted transverse crack in the northbound section of the project. Each of the three samples is about 1 m long, 0.3 m wide, and the full depth of the pavement.

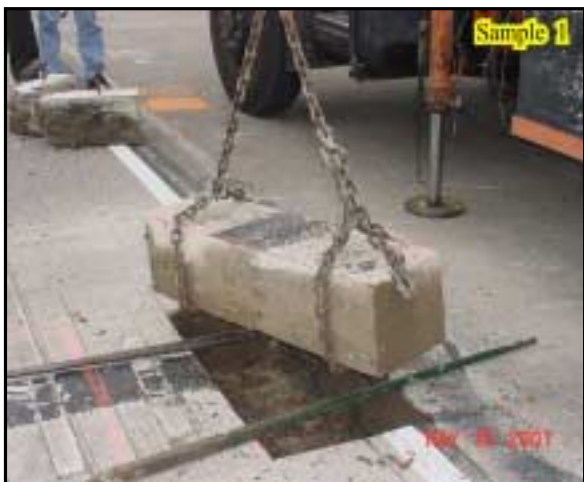
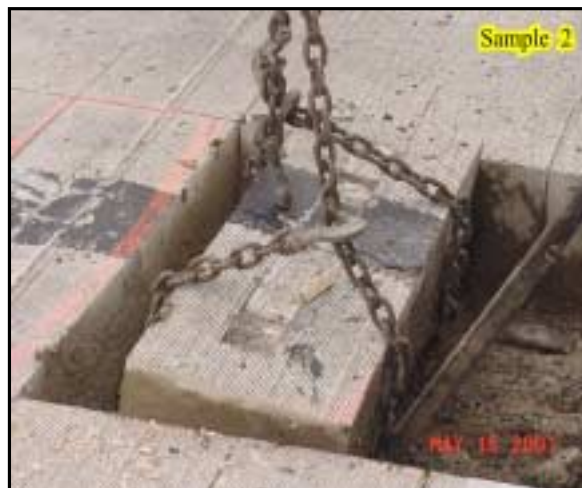
**Figure 10.** Samples 1 and 2 removed from Transverse Crack

The samples will be tested to evaluate the backfill grout, placement/alignment of the dowel bars, and depth of the slot.

Samples will be evaluated in the laboratory. Evaluations will include measurements, radiographic imaging, strength testing, and grout composition.
